21 Preservation Briefs

Technical Preservation Services

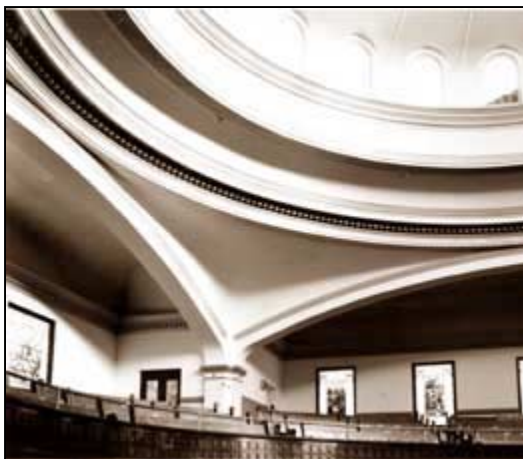
Plaster was used as the interior surface coating of this

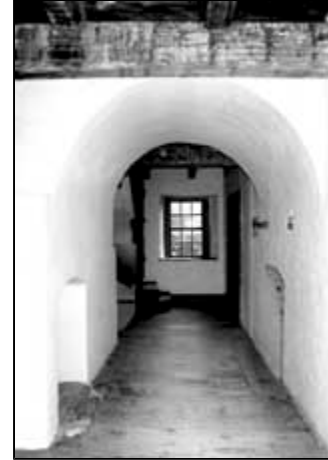
Schifferstadt, a simple house of German origin that dates to 1756, utilized plaster for both flat and curved walls. The building is located in Frederick, Maryland. Photo: NPS files.

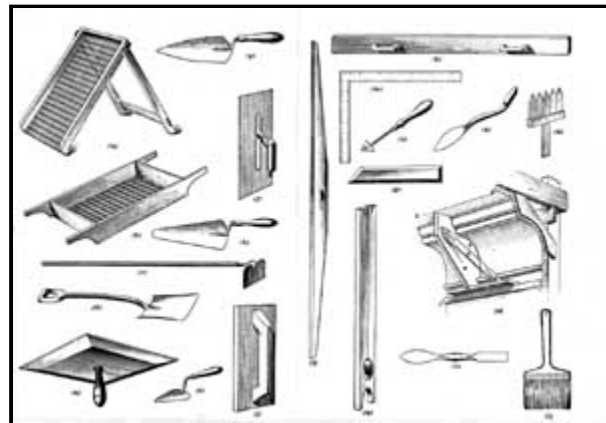
Many of these traditional plastering tools are still used today. Drawing: NPS files.

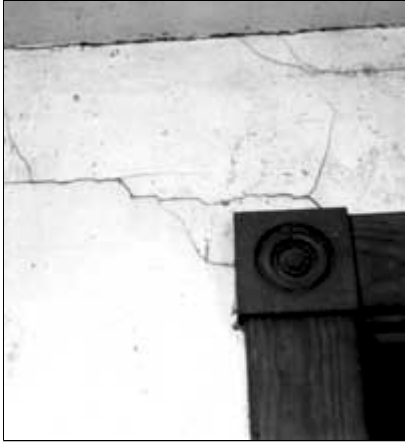
Stress cracks in plaster over a kitchen door frame can be repaired using fiberglass mesh tape and joint compound. Photo: NPS files.

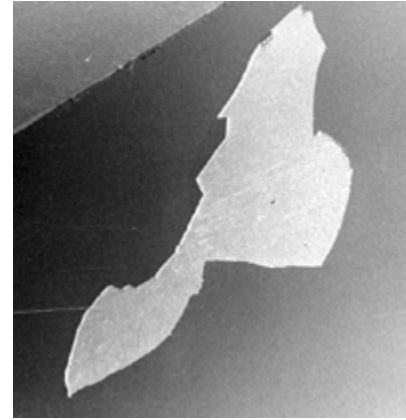
The smooth-troweled lime finish has delaminated from the brown coat underneath. Photo: Marylee MacDonald.

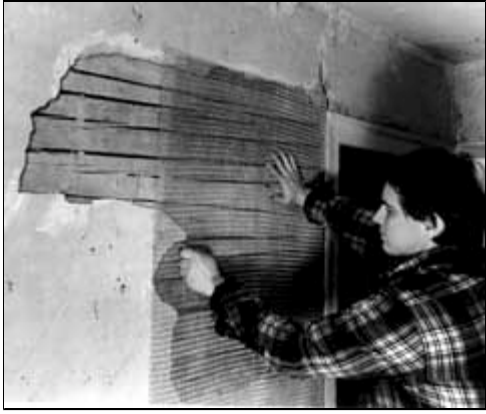
In this New Hampshire residence dating from the 1790s, the original plaster was a single coat of lime, sand, and horsehair applied over split lath. A one-coat repair, in this case, is appropriate. Photo: John Leeke.

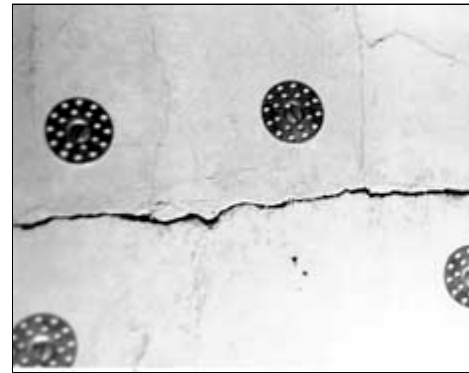
Flat-head wood screws and plaster washers were used to reattach loose ceiling plaster to the wood lath. After the crack is covered with fiberglass mesh tape, all will be skim-coated with a patching compound. Photo: John Obed Curtis.

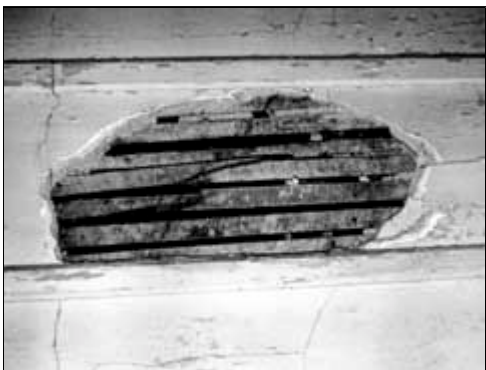
This beaded ceiling in one of the bedrooms of the 1847 Lockwood House, Harpers Ferry, West

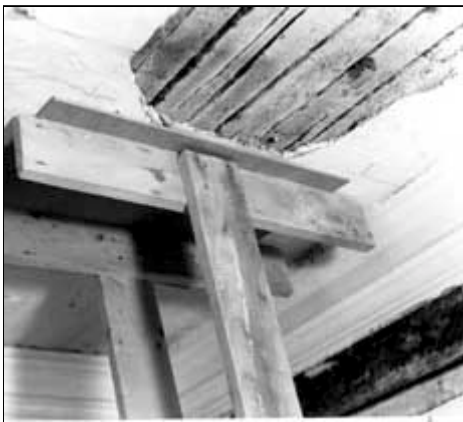
When ceiling repairs are made with wet plaster or with an injected adhesive mixture, the old loose plaster must be supported with a plywood brace until re-keying is complete. Photo: John Leeke.

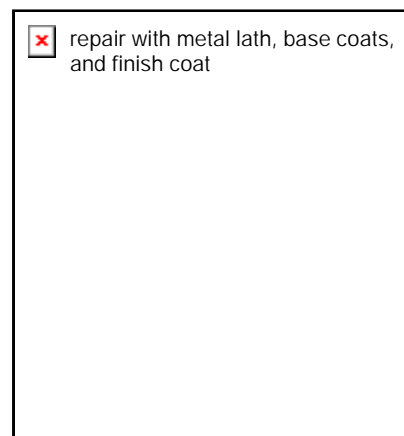
Repairs are being made to the historic plaster. Expanded metal lath is cut to fit the hole, then attached to the wood lath with a tie-wire. Two ready-mix gypsum coats are applied, then a smooth-trowled coat of gauged lime. Photo: Walter Jowers.
